DOT/FAA/RD-80/112

Lime-Stabilized Native Soil As A Base Course For Light Aircraft Pavement

B.B. BROWNIE

April 1981

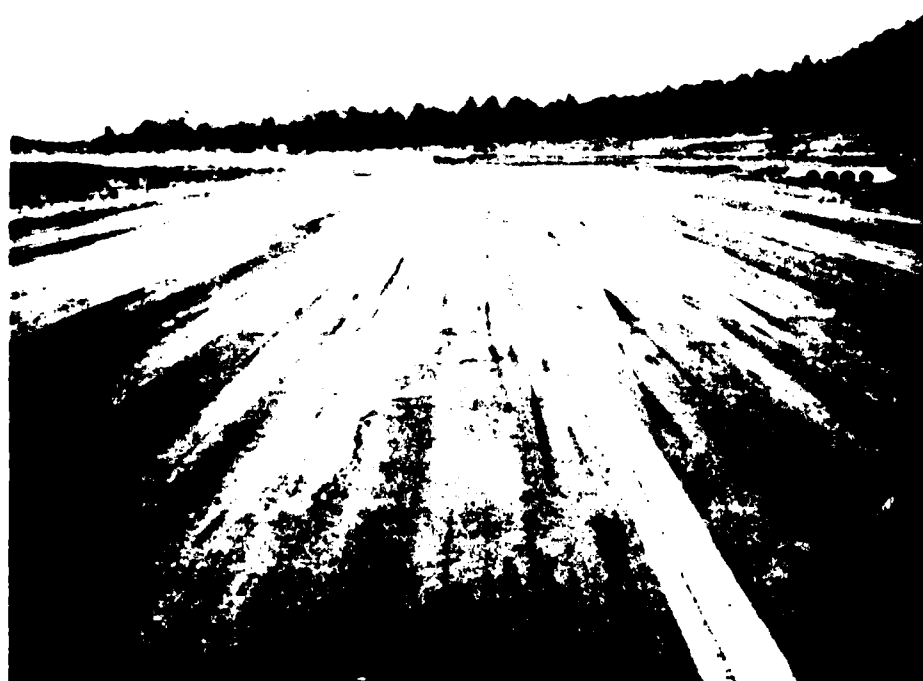
Figure 7. Longitudinal cracking in area subsequently repaired, Runway 7-25, Big Bear Airport.

Big Bear Airport. Runway and Taxiway 7-25 were constructed in 1973 and with the exception of an area of approximately 6,000 square feet near the 07 end of the runway was in excellent condition. The distressed area was located from station 5+25 to 7+78 and from 3 feet left to 28 feet right of the centerline. The major defects in this area were longitudinal cracks up to 1 inch wide and upheaval of the pavement surface along these cracks. This area is shown in Figures 7 and 8. Repairs were made in this area in August, 1978. During the repairs seams of unmixed lime were found along the cracks and these were believed to be the major causes of the distress. Some other minor longitudinal cracking was noted one to two feet from the pavement edges. The designers

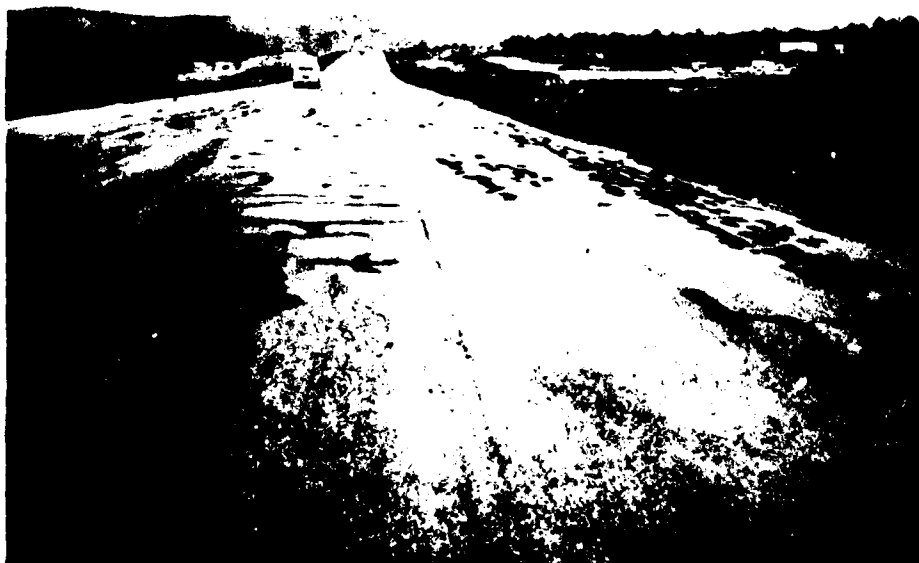
Figure 9. Typical cracks in Runway 6-24, Payson Airport.

Payson Airport. Runway 6-24 and the adjacent ramp area which were constructed in 1975 were in good condition in 1978. The major defects noted were longitudinal and transverse cracks which had been sealed. Typical cracks found are shown in Figure 9. These cracks are reported to have appeared during the six months after construction which led to concern that the pavement was failing. Investigation by the parties involved in the construction did not elicit a single cause for cracking. Suggested causes were poor mixing of lime, inadequate lime-stabilized layer thickness, curing shrinkage, and expansion of subgrade soil. The cracks, while unsightly, did not impair operation of the airport. The cracks were sealed and few new cracks subsequently appeared. During the field portion of this investigation, a core was taken of one of the sealed cracks to determine how deep the cracks penetrated. The crack and the coring operation are shown in Figure 10. The core recovered is shown in Figure 11. This crack occurred at a thin section of the lime-stabilized soil, 5.5 inches versus 12.0 inches design thickness. The crack went through the asphalt concrete surfacing and the lime-stabilized soil but did not appear to continue into the subgrade. The thinner than design section appeared to function as a weakened plane joint which allowed shrinkage cracks to occur.

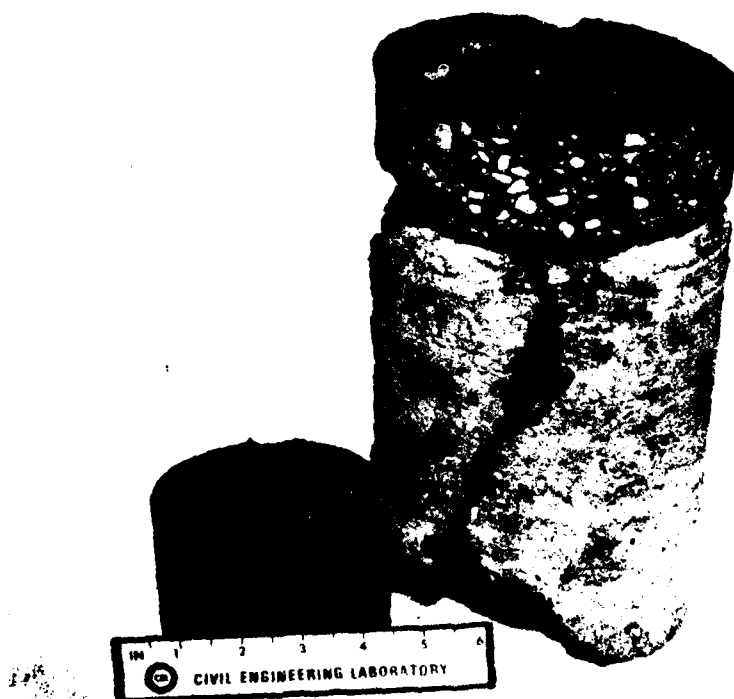
Figure 11. Core from crack shown in Figure 10. Note filler full depth of crack and uneven stabilization, Payson Airport.

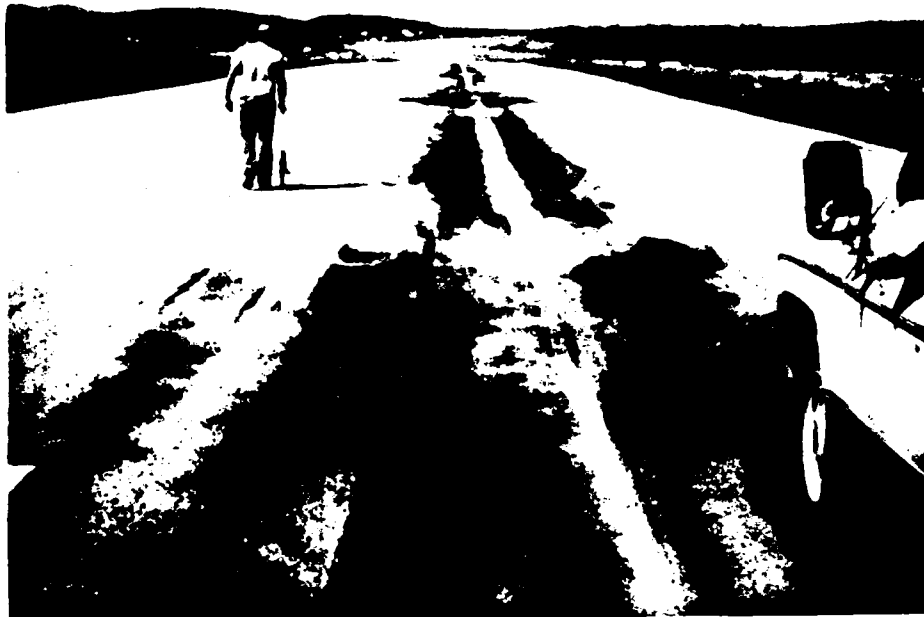
Figure 12. Bleeding of asphalt in one paving lane, Runway 6-24, Payson Airport.

Other minor defects noted during the visual survey were unrelated to lime-stabilization and included bleeding of the asphalt surfacing in some paving lanes (Figure 12) and slight raveling of the surface.

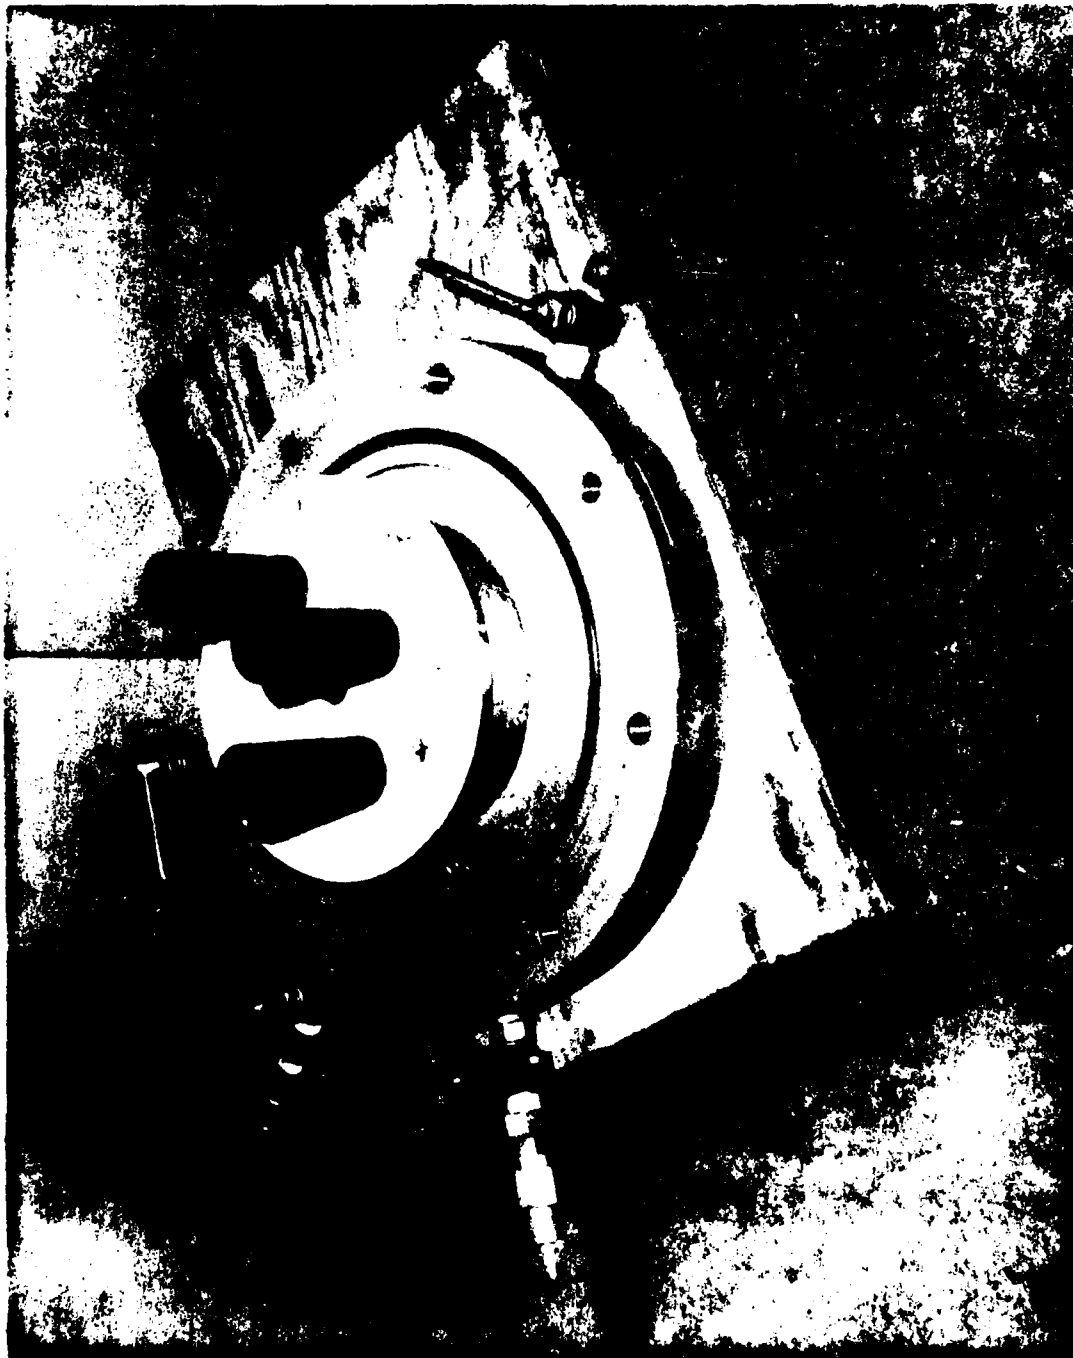
Figure 28. Lime-stabilized samples ready for vacuum saturation in triaxial cell.
